Better Than Before

Roof of Texas Business Gets New Life After Hailstorm

CMS MAGNETICS CORPORATION GARLAND, TEXAS

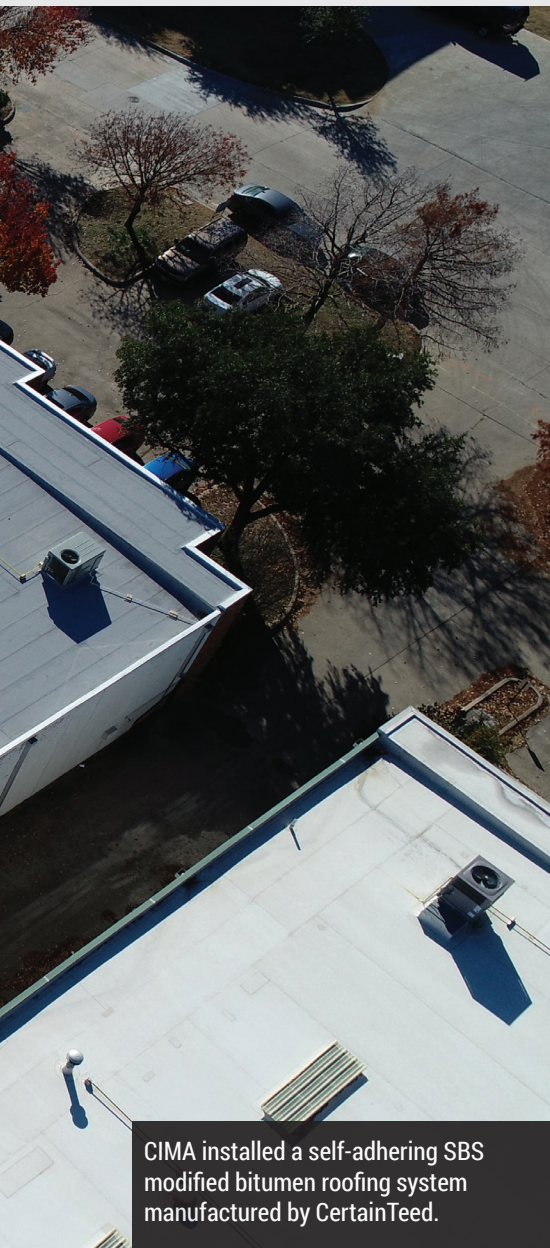
CIMA installed a self-adhering SBS modified bitumen roofing system manufactured by CertainTeed.

CIMA then applied CertainTeed's Black Diamond Base Sheet, a self-adhering SBS modified bitumen roofing membrane designed to provide durability, strength, ease of handling and resistance to moisture and wind-driven rain. A torch-applied layer of CertainTeed's Flintlastic GTA cap sheet topped off the system, providing additional puncture and tear resistance. The new, more resilient system delivered a combined 220 mils of protection.

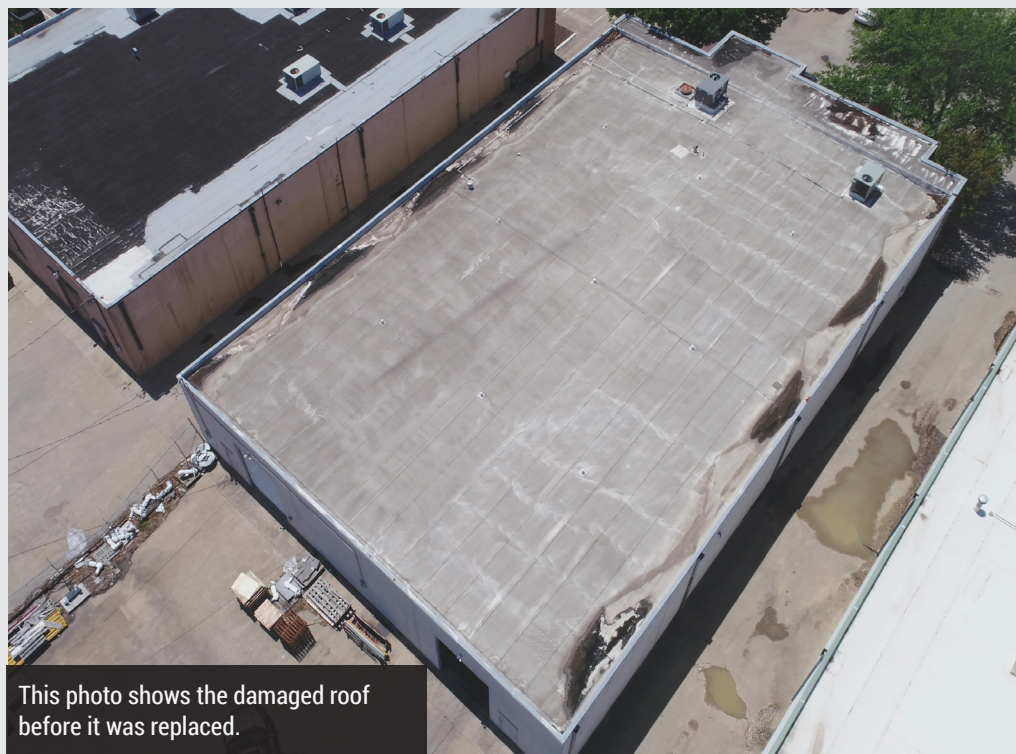
The existing roof assembly was comprised of a 22-inch intermediate-rib steel deck supporting a 60-mil PVC roof system along with a spray-on coating. CIMA decided to take a different approach – one that would offer a solution with greater energy efficiency, better tolerance for the foot traffic required for facility maintenance, and superior impact

This photo shows the damaged roof before it was replaced.

After removing the old roof system, CIMA mechanically attached CertainTeed's FlintBoard ISO insulation to the building's steel deck. In addition to helping the structure meet city building code requirements, the insulation provided year-round indoor comfort. CIMA also installed tapered FlintBoard ISO-T insulation to reconfigure the cricket geometry and sumps in the roof's corners and redirect water runoff to a new drainage system, eliminating standing water on the roof's surface.
